喜马拉雅中段冰湖终碛坝体溃决过程实验研究

Experimental study on the process of end-moraine dam failure in the middle Himalaya glacial lake: Taking the Jialongcuo glacial lake end-moraine dam as an example

喜马拉雅中段冰湖终碛坝体溃决过程实验研究 ——以嘉龙错冰湖终碛坝为例

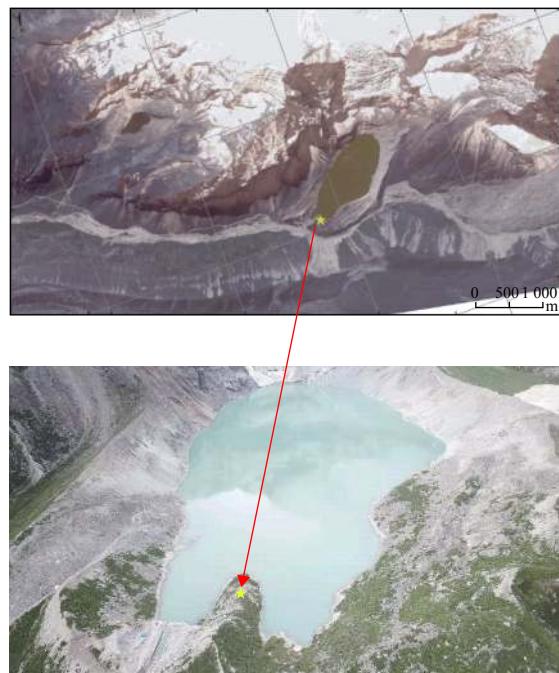
图1 原位实验地理位置和局部背景图

Fig. 1 The location of prototype water tank experimental and local background map

实验原型为嘉龙错冰湖,嘉龙错位于波曲河流域的冲堆普子流域上游,距离聂拉木县城直线距离约15.8 km(图1)。冰湖类型为终碛湖,其轴线西南方向的山腰发育有现代冰川,东南和西北方向均为侧碛垄,终碛坝位于东北方向。嘉龙错在2002年5月23日和6月29日先后两次暴发大规模泥石流灾害^[19]。嘉龙错目前处于溢流

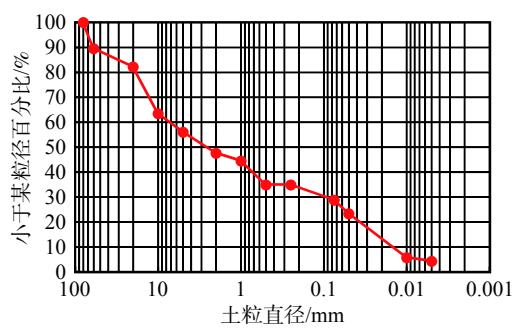
图 2 坝体材料颗粒分部曲线

Fig. 2 Particle division curve of the dam material

在水槽处取土密封后带回,在实验室内分别测量了坝体材料在天然含水率和饱和状态下的黏聚力和内摩擦角(表 1),其中内摩擦角的值要比其他区域的冰碛土小,黏聚力介于最大值和最小值之间。堰塞坝的这两个参数变化范围较大,通过分析并参考国内的一些典型堰塞坝参数,本实验中土样黏聚力的值接近于易贡堰塞坝,内摩擦角的值接近于唐家山堰塞坝^[15, 18]。坝体材料颗粒级配曲线由筛分法获得(图 2),从图 2 中可以看出,粒径在 10~20 mm 的颗粒含量较多,黏粒含量为 4.2%,相比于堰塞坝,终碛坝的黏粒含量偏小^[18]。

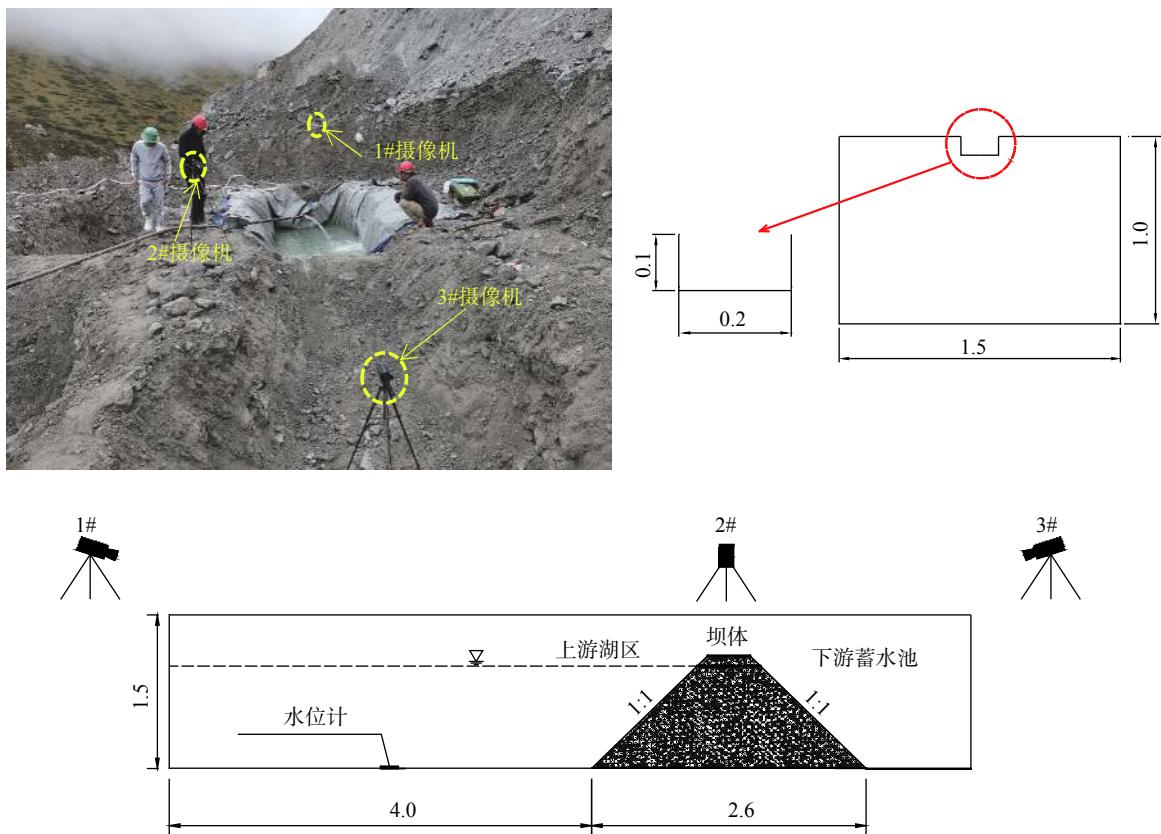
图3 实验设备布置以及初始溃口形态(单位:m)

Fig. 3 Experimental equipment arrangement and initial morphology of breach (unit:m)

龙错的轴向长度与平均宽度之比约为 2.66,以宽度作为基准,实验水槽上游湖区长度与宽度的比值取为 2.66。上游湖区宽度根据挖掘机挖斗的宽度设置,大小为 1.5 m,计算可得上游湖区长度约为 4 m。采用挖掘机对水槽进行了开挖,在开挖过程中,坝体表面不可避免地发生了轻微扰动,在挖掘机开挖后,采用人工作业去除了表面的扰动土,因此坝体依旧为原位状态。水槽系统的结构如图 3 所示,由上游湖区、坝体、下游蓄水池、水位计和 3 台摄像机组成。根据坝体尺寸的不同,水槽的总长为 6.6~7.2 m,宽 1.5 m,深 1.5 m,其中上游湖区长 4 m,坝体底宽 2.4~3.0 m,深 1 m,坝体上下游坡度均为 1:1,以坝顶宽为 0.4 m 为例,其坝底宽为 2.6 m。实验预设了初始溃口,位于坝体中部,初始溃口宽 0.2 m,深 0.1 m(图 3、图 4)。

实验过程中水位的变化通过上游湖区底部的一个水位计(RR-1840)记录,频率为一秒一次,然后以水位计的数据为基础,通过式(1)和式(2)计算流量,计算所得流量按照一分钟一次进行平均处理,以减小数据波动带来的误差。在实验过程中也未见坝体渗流现象,因此在溃坝过程中忽略渗流的影响,认为每一秒计算所得的流量为此时刻的真实流量。三台高清摄像机(索尼 FDR-AX60, GOPRO7, 索尼 HDR-PJ820E)分别位于蓄水区上游,坝肩一侧和坝体下游,用来捕捉溃口的演变过程。1#摄像机记录溃决过程中上游湖区的变化情况,2#摄像机用于记录溃口的下切过程,3#摄像机用于记录溃口的展宽过程和下游坝坡的变化。

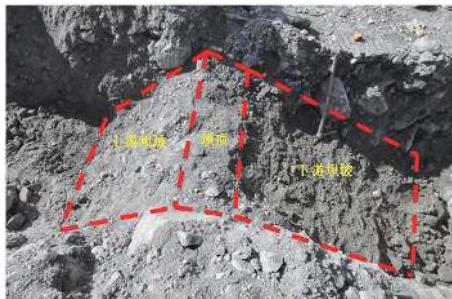
图4 坝体形态图

Fig. 4 Diagram of dam morphology

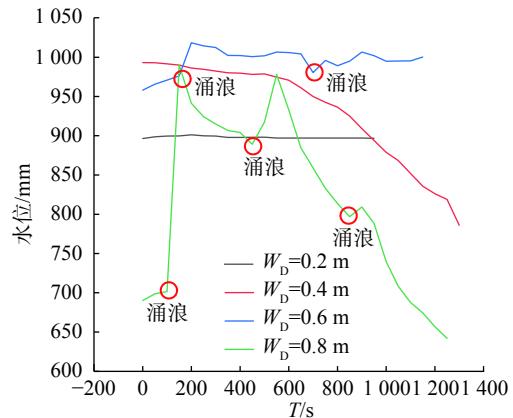
图5 W_D 为0.8 m时的库区水位变化曲线Fig. 5 Curve of water level change in the reservoir area when W_D is 0.8 m

实验中,上游湖区边坡没有发生崩塌现象,故而没有在湖区内激发产生涌浪。在 W_D 为0.6 m和0.8 m的实验中,上游湖区边坡有崩塌现象产生,崩塌体在湖区内激发产生涌浪,同时由于崩塌体进入湖区内,造成湖区水位急速上升(图5),使得溃决流量激增。如图5所示,每一次水位的突变都对应着一次崩塌涌浪过程。但无论是否有涌浪,溃决过程都可以划分为四个阶段,第一个阶段为坝体下游坡面冲刷,第二阶段为溃口内的“溯源侵蚀”过程,第三阶段为出水口下切,第四阶段为溃口

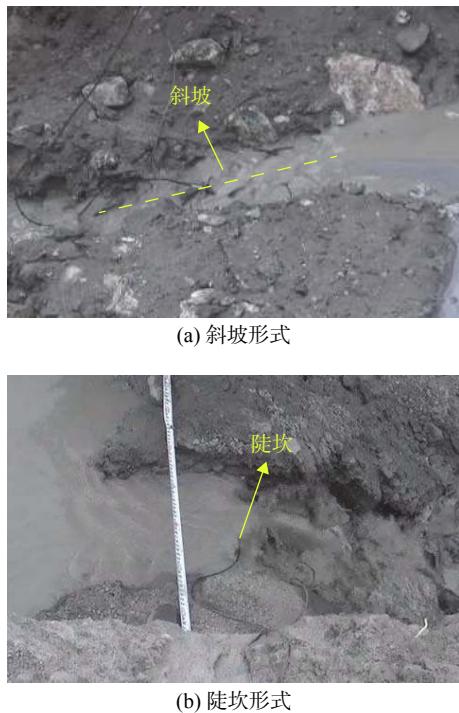
图 6 两种形式的溃口下切过程

Fig. 6 Two forms of undercutting process

拓宽。在有涌浪的溃决过程中,由于崩塌入湖造成湖区水位的急速上升,因此在溃决伊始,溃决的流量较大,往往表现出以斜坡的形式进行“溯源侵蚀”(图6)。在无涌浪的溃决过程中,湖区水位没有急速上升的现象,因此溃决开始后的一段时间内,溃决流量相对较小,往往表现出以陡坎的形式进行“溯源侵蚀”(图6)。

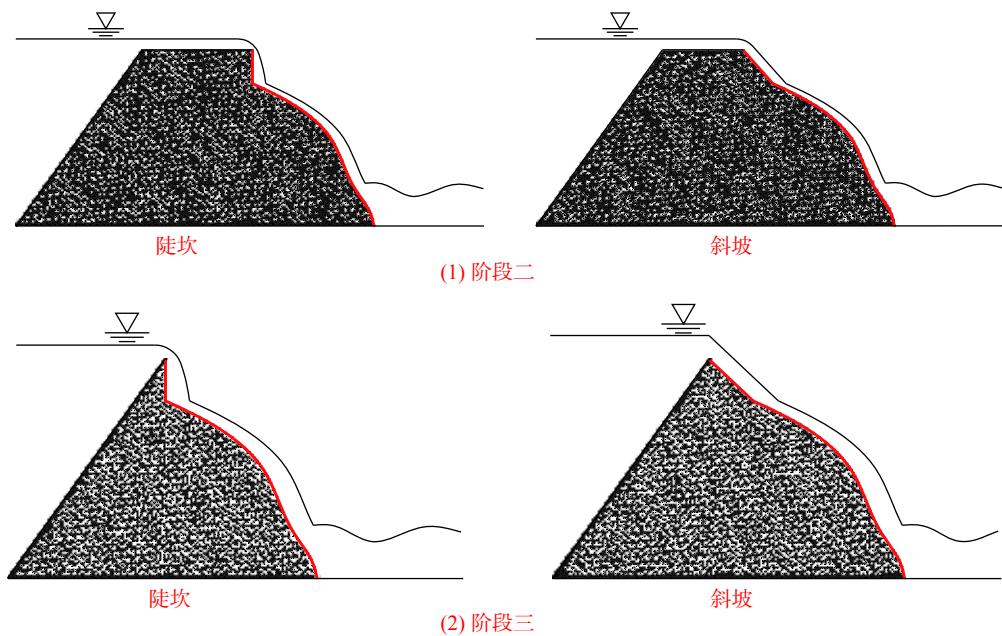
图 7 陡坎和斜坡在阶段二和阶段三的发展示意图

Fig. 7 Schematic diagram of the development of steep and slope in Stages 2 and 3

在以斜坡形式进行“溯源侵蚀”的过程中, 当上游湖区的涌浪发生后, 在涌浪和坝前水位急速上升的共同作用下, 溃决流量显著增大, 使得陡坎转化为斜坡。斜坡形成后, 斜坡表面的泥沙颗粒随溃决水流发生输移, 使得斜坡发生“溯源侵蚀”现象。当斜坡顶部发展到上游湖区出水口时, 斜坡停止发展, 此时进入溃决的第三阶段(图 7)。

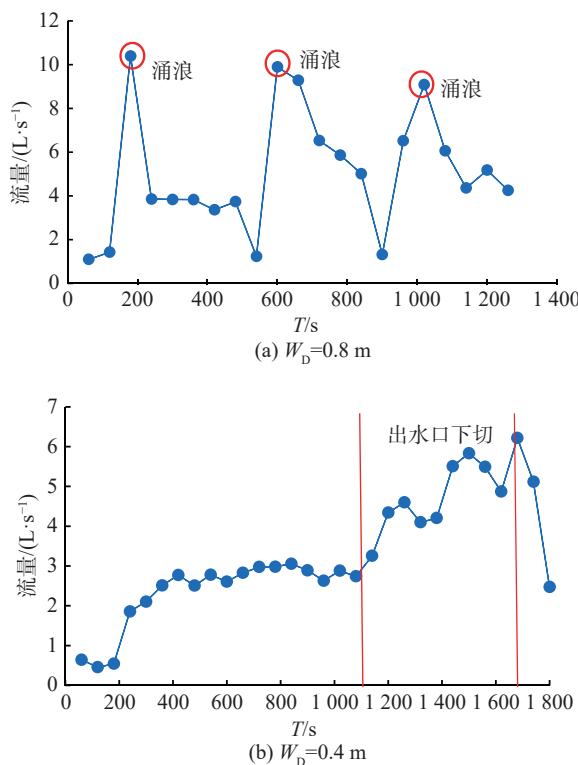
图 8 W_D 分别为 0.8 m (斜坡) 和 0.4 m (陡坎) 时的流量曲线
Fig. 8 Flow curves at W_D of 0.8 m(slope) and 0.4 m(stEEP), respectively

阶段三: 以陡坎形式进行“溯源侵蚀”的过程中, 当陡坎停止发展时, 由于此时的坝体变薄, 水流的冲刷作用将使溃口位于出水口的部分“快速”下切。由于坝前水位不会发生突变, 因此出水口处的水流流深会快速增大, 根据堰流式(3)的描述, 溃决流量也会迅速增大, 在 W_D 为 0.4 m 时, 进入第三阶段后, 溃决流量从 2.8 L/s

上升至 6.2 L/s, 达到洪峰状态(图 8)。以斜坡形式进行“溯源侵蚀”的过程中, 当斜坡停止发展时, 此时的坝体相对于陡坎形式而言更厚, 因此出水口的下切速度更小, 水流流深也相对较小, 溃决流量的变化率也更小, 这一类型的洪峰流量一般是由崩塌涌浪造成的, 如 W_D 为 0.8 m 时, 在图 8 中, 溃决流量在第 180 s 时, 从 1.3 L/s 突然增大至 10.6 L/s。由于崩塌体入湖导致坝前水位上升, 使得涌浪过后, 溃决流量依然较大, 如 W_D 为 0.8 m 时, 第 240 s 至 480 s 的流量曲线。

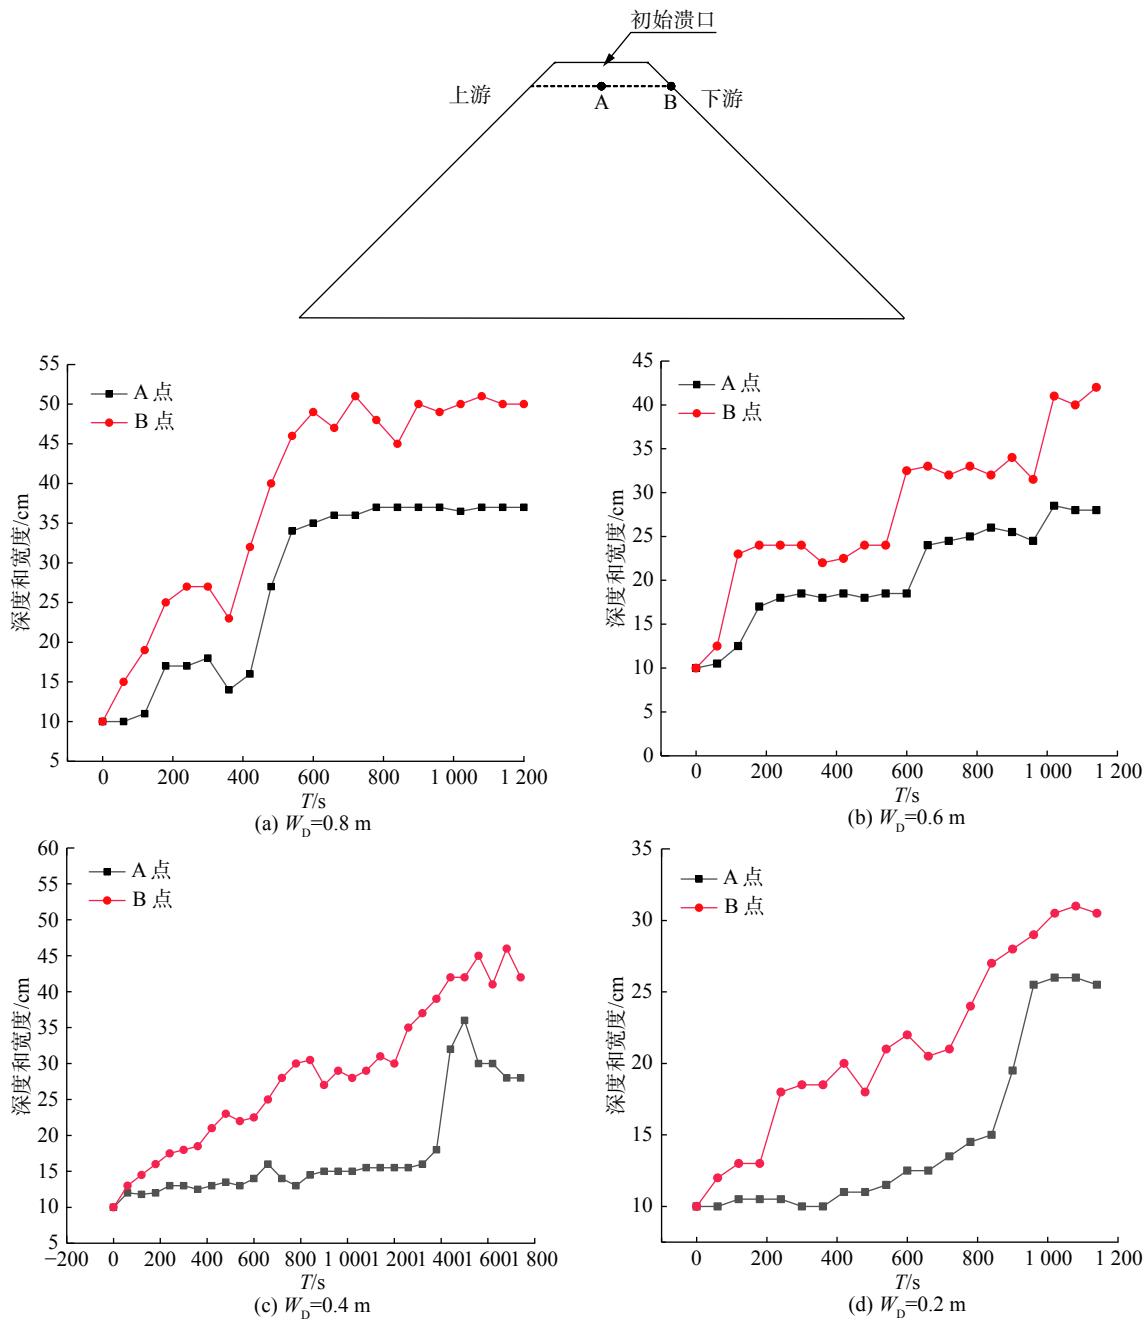
图 9 坝顶宽为 0.2~0.8 m 时的溃口深度变化曲线

Fig. 9 Curves of breach depth for dam crest widths from 0.2 m to 0.8 m

B 点的深度, 根据测量数据得到了四组实验中 A 点和 B 点的深度变化曲线(图 9)。溃口的下切是水流冲刷作用和坝体物质抗冲刷作用相互抗衡的结果, 主要的贡献者为“溯源侵蚀”过程。图 9 展示了 W_D 从 0.2 m 至 0.8 m 的溃口深度变化曲线, 从图 9 中可以看出, 在四组实验中, A 点的深度都要小于 B 点。当 W_D 为 0.6 m 和 0.8 m 时, 两点深度的变化趋势几乎一致。而当 W_D 为 0.2 m 和 0.4 m 时, A 点的深度在前期变化非常缓慢, 分别在第 860 s 和第 1380 s 发生跳跃, 变化趋势与 B 点完全不同。

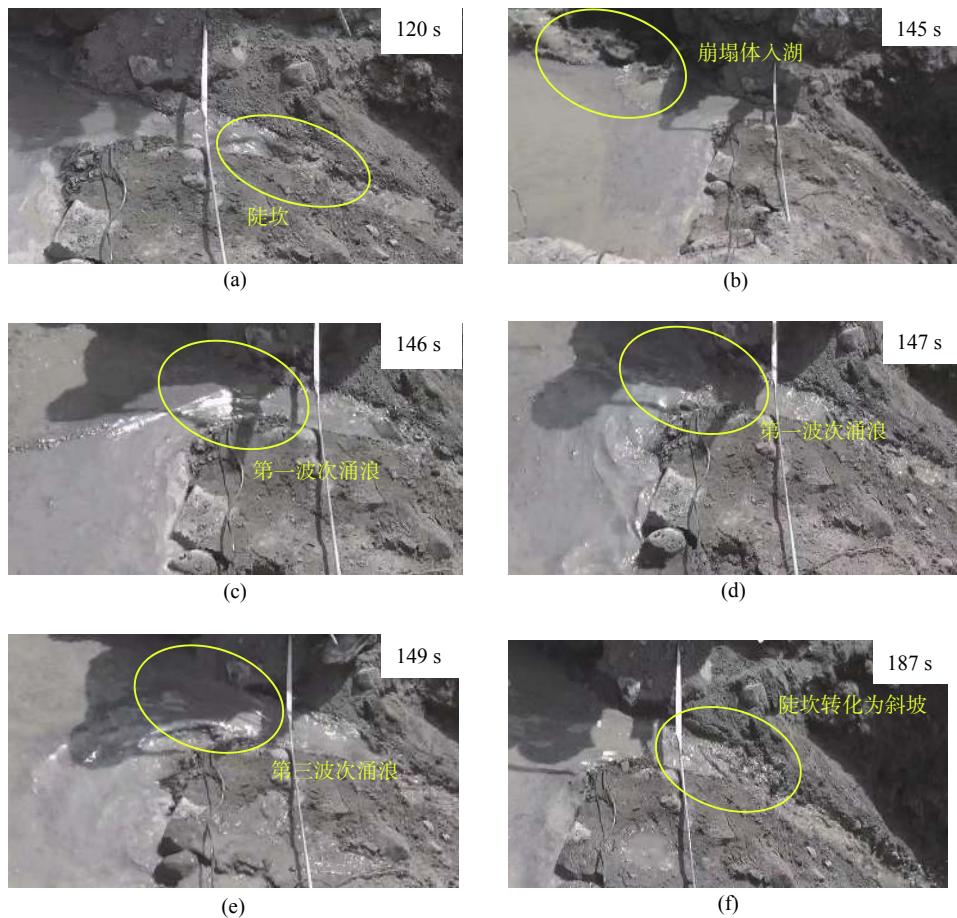
图 10 W_D 为 0.6 m 时陡坎转化为斜坡的过程Fig. 10 The process of transforming a steep hill into a slope when W_D is 0.6 m

通过对实验视频的解析发现, 当 W_D 为 0.6 m 和 0.8 m 时, 上游湖区边坡有崩塌发生, 崩塌体入湖后激发了涌浪, 并导致坝前水位急速上升, 在这两组实验中, “溯源侵蚀”过程以斜坡的形式进行(图 10)。而当 W_D 为 0.2 m 和 0.4 m 时, 上游湖区边坡没有崩塌发生“溯源侵蚀”过程以陡坎的形式进行(图 11)。事实上, 所有组次实验在溃决刚开始时都会形成陡坎, 但 W_D 为 0.6 m 和 0.8 m 时, 由于涌浪发生在溃决伊始, 在涌浪冲刷和坝前水位上升双重因素的作用下, 溃决流量迅速增大, 水流侵蚀能力迅速增强, 使得陡坎快速转化为斜坡, 如图 10 所示, 而 W_D 为 0.2 m 和 0.4 m 时, 溃决过程无涌浪, 因此一直保持陡坎的形式“溯源侵蚀”。

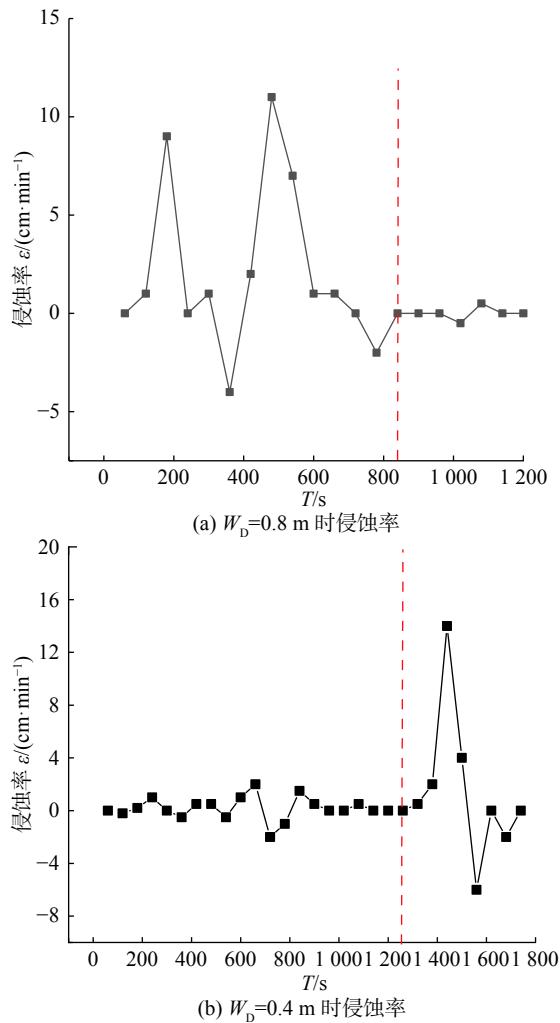
图 11 坝顶宽分别为 0.8 m 和 0.4 m 时的溃口 A 点侵蚀率

Fig. 11 Erosion rate at breach A for dam crest widths about 0.8 m and 0.4 m, respectively

基于此, 对溃决过程的侵蚀率进行了分析。将 W_D 分别为 0.8 m 和 0.4 m 作为有涌浪和无涌浪的代表, 以 A 点的侵蚀率为例进行说明。两组实验中 A 点的变化率如图 11 所示, 图 11 中侵蚀率为正表示 A 点有下切, 侵蚀率为负表示 A 点有沉积。从图 11 中可以看出, W_D 为 0.8 m 时, A 点的侵蚀率在第 840 s 前变化较为剧烈, 840 s 后基本保持在 0 附近波动。 W_D 为 0.4 m 时, A 点的侵蚀率在第 1260 s 前虽有波动, 但变化量相对于 1260 s 后要小得多, 特别是在第 1260 s 发生了一次较大的突跃。

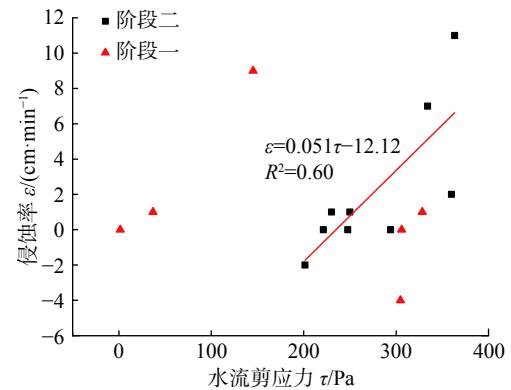
图 12 W_D 为 0.8 m 时的溃口 A 点侵蚀率与水流剪应力关系

Fig. 12 Relationship between erosion rate and water flow shear stress at breach A for a dam crest width about 0.8 m

当 b 相对于 h 足够大时, 可以近似用 h 来代替^[21]。根据以获取的数据, 以 W_D 为 0.8 m 为例, 计算了 A 点每一分钟末的水流剪应力。在计算某一分钟的平均剪应力时, 将上一分钟末和这一分钟末的水流剪应力进行平均作为这一分钟的平均剪应力。获得水流剪应力后, 拟合了水流剪应力与侵蚀率之间的关系。从图 12 中可以看出, 侵蚀率在阶段二与水流剪应力有较好的线性关系。

计算可知, 当坝顶宽为 0.8 m 时, 可侵蚀系数和临界剪应力分别为 0.051 和 237.64 Pa。与前人实验结果的对比, 本实验 k_d 偏小而 τ_c 偏大(表 2)。这也意味着终碛坝要比滑坡堰塞坝更加难以侵蚀。
